## EAVE with 7" BARGE GUTTER DETAIL

ROOF PANEL: MIRAGE II

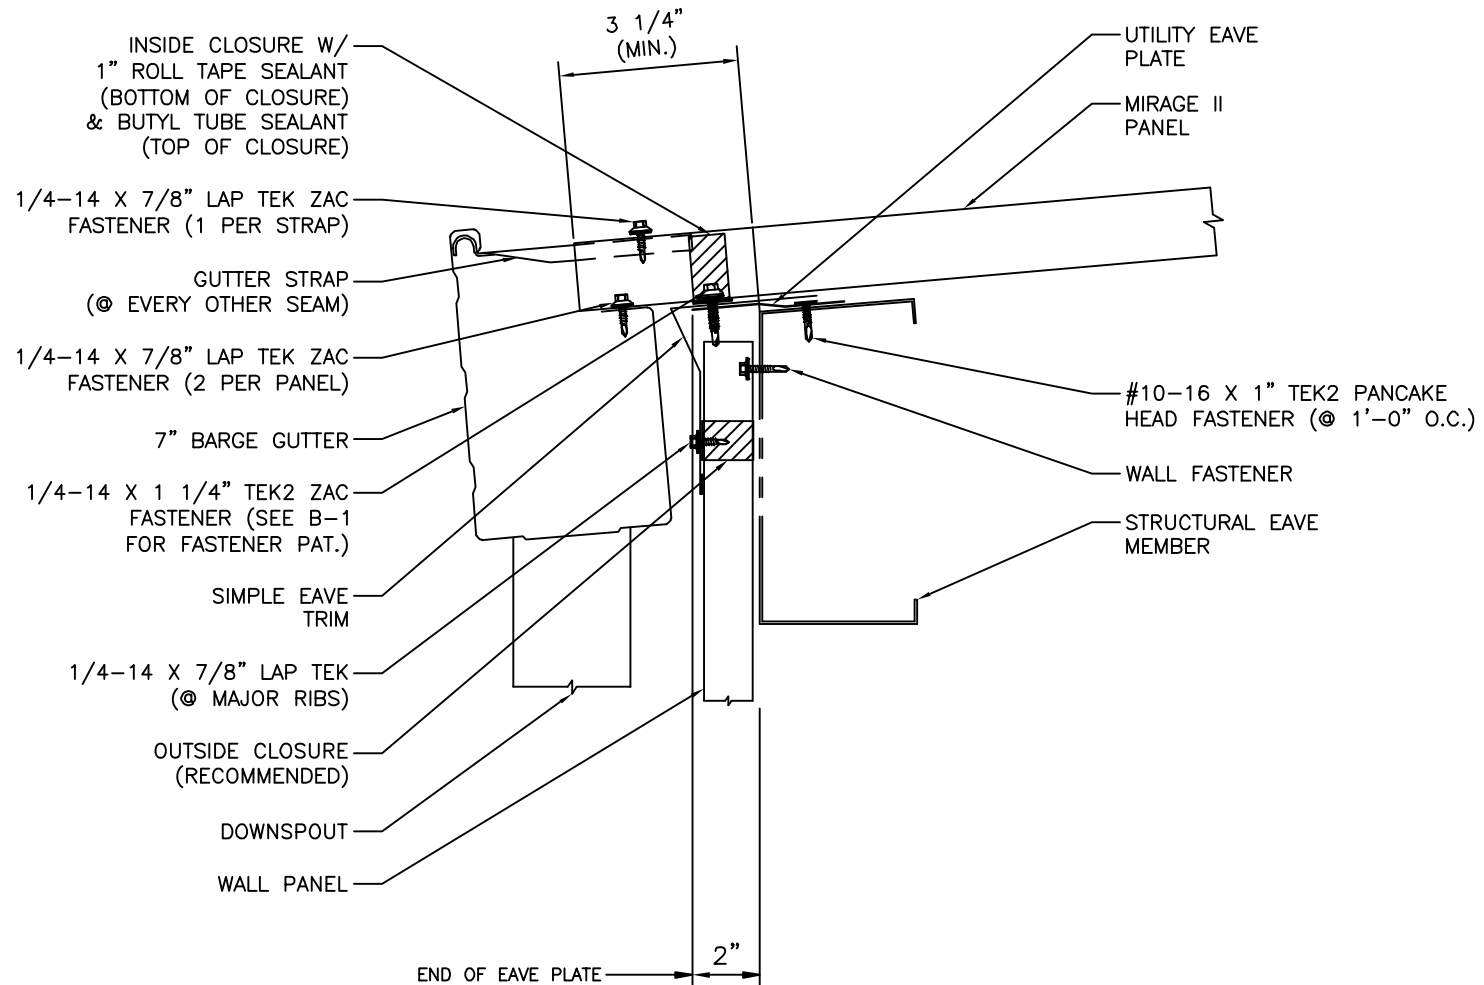
NOTE: SLIDING SNOW AND ICE COULD  
CAUSE DAMAGE TO GUTTER SYSTEM.

SUBSTRATE: DUBIUM
